The degradation of the “Study room” (Convent of Christ, Tomar, Portugal), from a preliminary analysis towards a sustainable maintenance

Fernando Costa, Manuel Rosa, Mattia Canetto, Maria Júlia Sobral da Fonseca

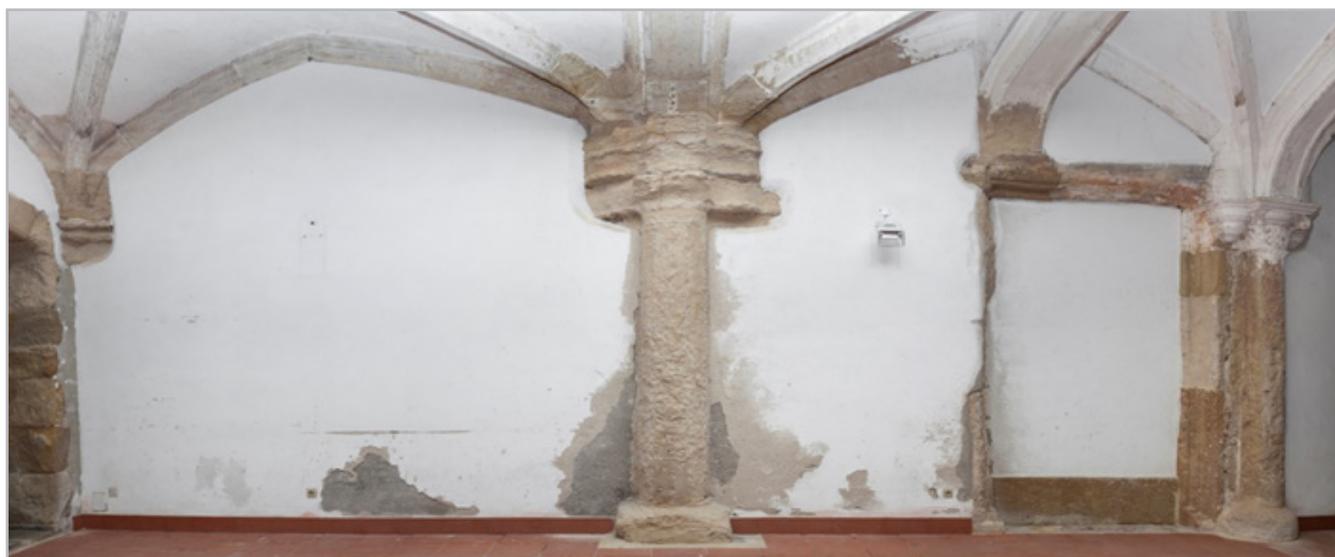
Figure 1.- Overview of the "Study Room" wall with the column under study in the centre.

The supported column seen in Figure 1 is in the “Study Room” which is located in the west side of the Crow’s Cloister, between the coffee shop and the cloister entrance. This room has two entrances: from the west gallery of the cloister and from the Executioners Courtyard.

This paper reports the practical procedures taken, which were aimed at fully understand how the current state of the supported columns of the "Study Room" (Figure 1) was reached, starting from an overall historical background and going through several confluent aspects to its current situation. In fact, for an accurate analysis and for the achievement of reliable results, it is necessary to widen the review in order to include the viewpoints of several disciplines including: Architectural Heritage, Conservation and Restoration of stone materials, Mineralogy, Petrology and Chemistry. Ultimately, it was intended, with the understanding thus acquired, to minimize the process that led to the degradation of the stone, due to the crystallization of soluble salts. [Figure 1].

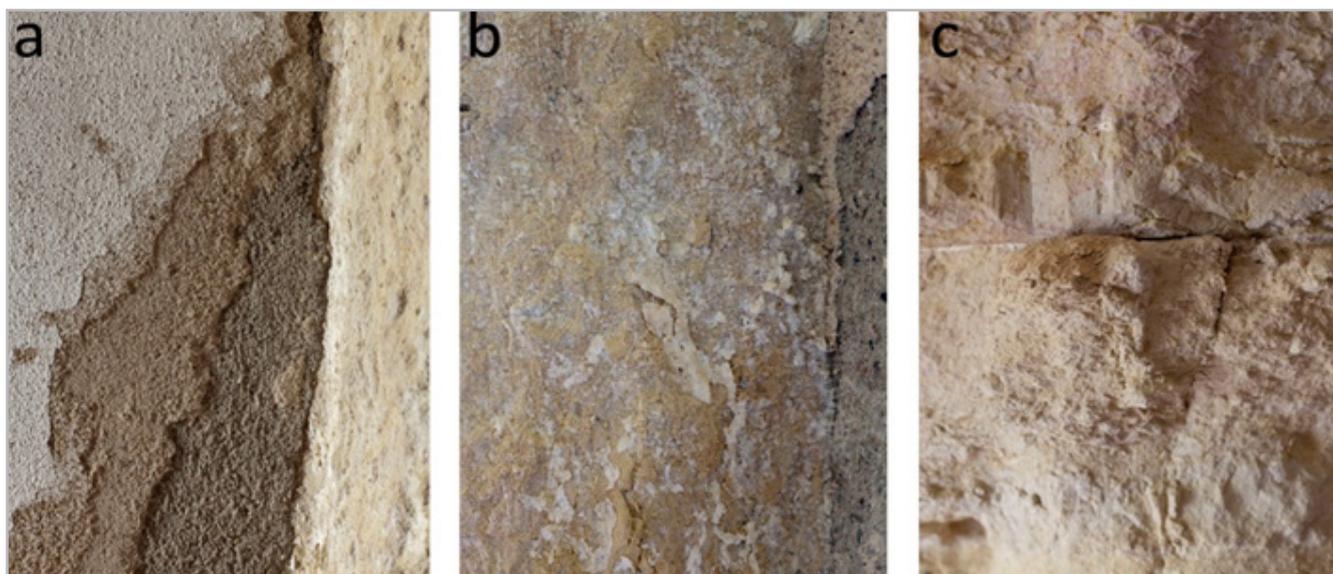
This limestone column is 3.5 m high in total. Its petrous material was in an advanced state of degradation caused by cement mortar ancient repairs, followed by efflorescence and erosion as shown in Figure 2. Humidity stains, pulverization and cracks were also noticeable, all, important anomalies to the material, as for the normal and healthy use of the room; in addition to the aesthetic degradation, loss of historical material was reported. Hence, the reduction of the mechanical strength of the materials and the construction elements (Puim *et al.* 2012 : 2). The phenomenon was found very worrying in all perspectives. [Figure 2]

Another factor that influenced the formation of efflorescences and especially their migration to the surface of the column is the presence of two layers of cement mortar. This is incompatible with the masonry of limestone. In fact, during the 20th century, in the restoration of masonry structures, there was a tendency to replace mortars with cement-based mortars. However, in several recent cases, extensive damage to the ancient masonry due to incompatibility of the cement-based mortars with the old materials has clearly been established. Indeed, cement-based mortars show a high content of soluble salts, potentially dangerous for decay of ancient mortar by crystallization and dissolution cycles (Lanas and Alvarez-Galindo 2003: 1867). In fact, the saline efflorescence was more abundant in the interface cement/column than in the central area of the column.

Figure 2.- Stone deterioration of the column: (a) cement mortar layers, (b) efflorescences and (c) erosion.

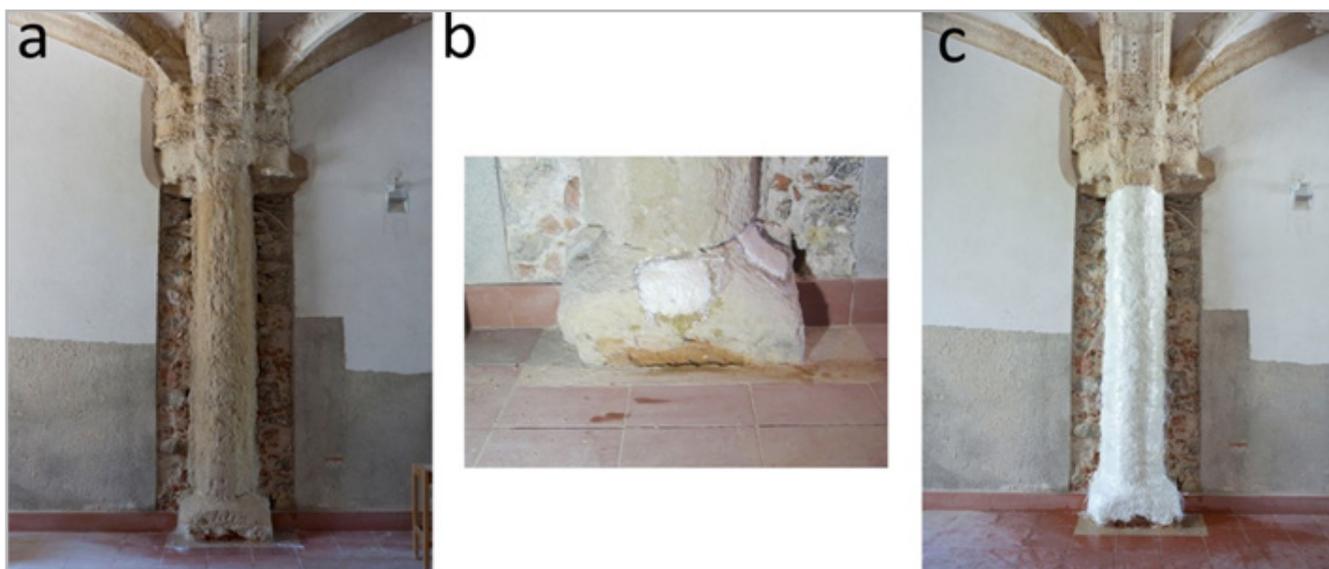
Meanwhile, starting the conservative intervention, the inadequate material has been removed, namely, the cement mortar around the perimeter of the column, reaching a distance of about 30 cm as presented in Figure 3a.

Figure 3.- Intervention of conservation; (a) removal of cement mortar, (b) the preliminary test of absorption with cellulose pulp ARBOCELL BC1000 and (c) the cellulose pulp applied over the entire surface of the column.

The time of application of the pulp was based on a preliminary test carried out (Figure 3b) on a portion of the surface (about 10x10 cm) and its duration was influenced by the time necessary to allow the pulp to dry (Franceschi and Germani 2005 : 176-178). Following the satisfactory results of the tests, absorbent pastes were applied over the entire surface of the column, as presented in Figure 3c. The extraction of soluble salts was performed in three cycles by applying the pulp (ARBOCELL BC1000, average fiber length 700 μ), to the entire surface of the column and respective chapter, allowing every cycle to perform extraction during of 48 hours. After each cycle, the pulps were removed at intervals of 20 cm with the help of scrapers, separated and taken to the laboratory where their conductivity was measured.

1) The pulps plasters were prepared by mixing 50 g of cellulose pulp with 200 ml of distilled water and were placed in selected areas, leaving them to act for a time of 48 hours. They were covered with plastic film to prevent its detachment and to avoid the quick evaporation of the water.

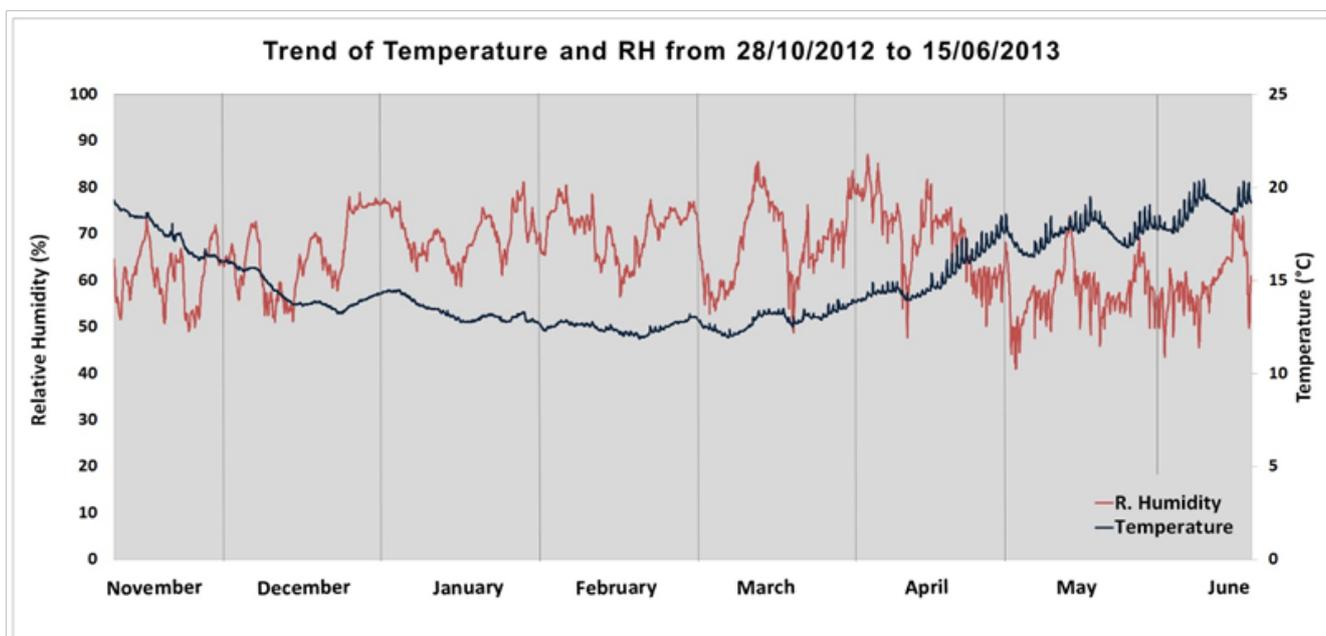
The monitoring of the “Study Room” microclimate is presented in the chart of Figure 4 where the temperature and relative humidity appear in function of time from early November to mid-June. The temperature did not have large variations in January and February but it clearly decreased in November and December and increased in March, April and June. The average temperature during the monitoring campaign was 15.0 °C with a maximum of 20.5 °C and a minimum of 11.9 °C. The relative humidity presented higher variations with an average of 65.7%, a maximum of 87.1% and a minimum of 41.0%. [Figure 4]

Figure 4.- Trend of Temperature and Relative Humidity of the “Study Room”.

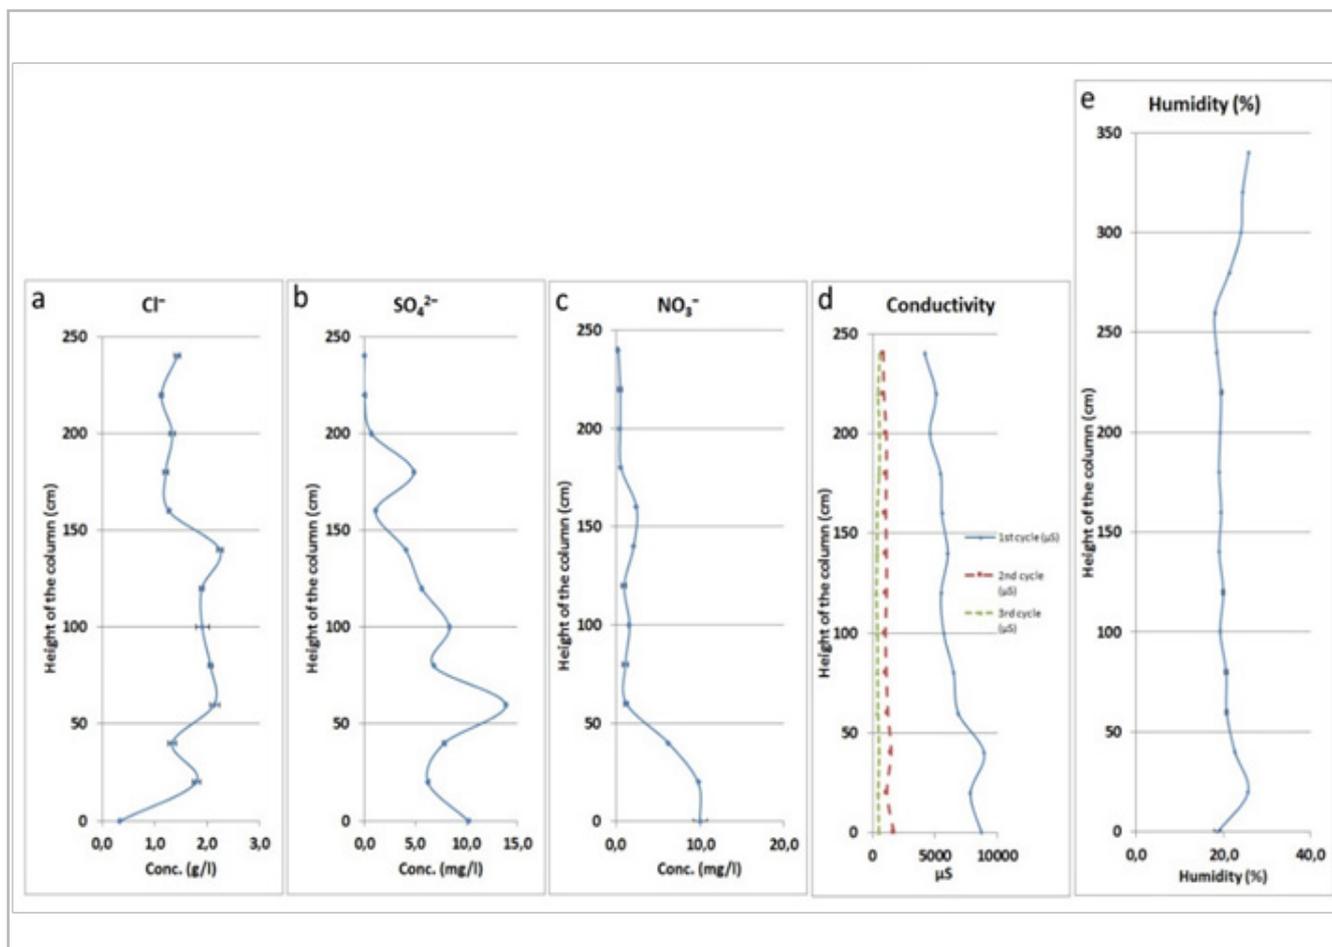
The higher humidity values in the upper part of the column (chapter), as shown in Figure 4e, are probably due to the infiltrations originated from the terrace situated above the room.

The values obtained for concentration of the analyzed ions presented in the efflorescences are shown in the charts of Figure 5. They reveal that the chloride salts have values about one thousand-fold higher compared to the sulfate and nitrate salts.

The profile of the distribution of the chloride salts on the surface of the column was mainly constant and this phenomenon is explained by the higher solubility and greater mobility of these salts compared to the other studied salts. The lowest obtained value of chloride ion concentration was 0.337 ± 0.018 g/l on the base of the column and the highest values on the lower half of the column ranging from 1.335 ± 0.057 g/l at 60 cm from the base to 2.245 ± 0.051 g/l at 140 cm from the base.

The concentration of the nitrate ion was higher on the base of the column with values of 10.029 ± 0.81 mg/l and 9.804 ± 0 mg/l at 20 cm from the base, the lowest value was 0.257 ± 0.107 mg/l at the top of the column (240 cm), this may be explained by the use of this room as a stable for some time in the past.

As to the sulphate ion, the obtained concentrations have an out-of-trend peak in the body of the column, at a height of 60 cm reaching the 13.858 ± 0.082 mg/l mark but the general trend is clearly of a decrease towards the top of the column starting at the bottom of the column with a concentration of 10.205 ± 0.137 mg/l and decreasing to 0 mg/l at the top of the column. This may be explained by the contact of the limestone column material with the cement mortar applied in the past at its base with a wave of sulphates progressing towards the top of the column.

Relative to the intervention, the obtained values on the three tests show a significant decrease of the conductivity from 2540 to 371 $\mu\text{S}/\text{cm}$ in the case of the central sample and from 3116 at 490 $\mu\text{S}/\text{cm}$ in the case of the sample on the right side. The cycles of absorption gave satisfactory results. The cycles of absorption were monitored by the analysis of the conductivity and revealed higher salt extraction at the base of the column, decreasing upwards, with lowest values at the top of the column. These results are in general accordance with the specific individual determination of the concentration of the three studied ions. From the first to the third application, in the base, the initial values that were close to 9000 $\mu\text{S}/\text{cm}$ fell to values close to 500 $\mu\text{S}/\text{cm}$ and, at the top, from values close to 5000 $\mu\text{S}/\text{cm}$ to 600 $\mu\text{S}/\text{cm}$, as can be seen in Figure 5d. A considerable quantity of salts was absorbed from the surface of the column. Also, the appearance of the stone improved. [Figure 5]

Figure 5.- Reference distances and respective distribution of the concentrations of (a) chlorine ion, (b) sulphate ion and (c) nitrate ion in the efflorescences, (d) conductivity of the cellulose after the tree interventions cycles and (e) surface humidity of the column limestone.

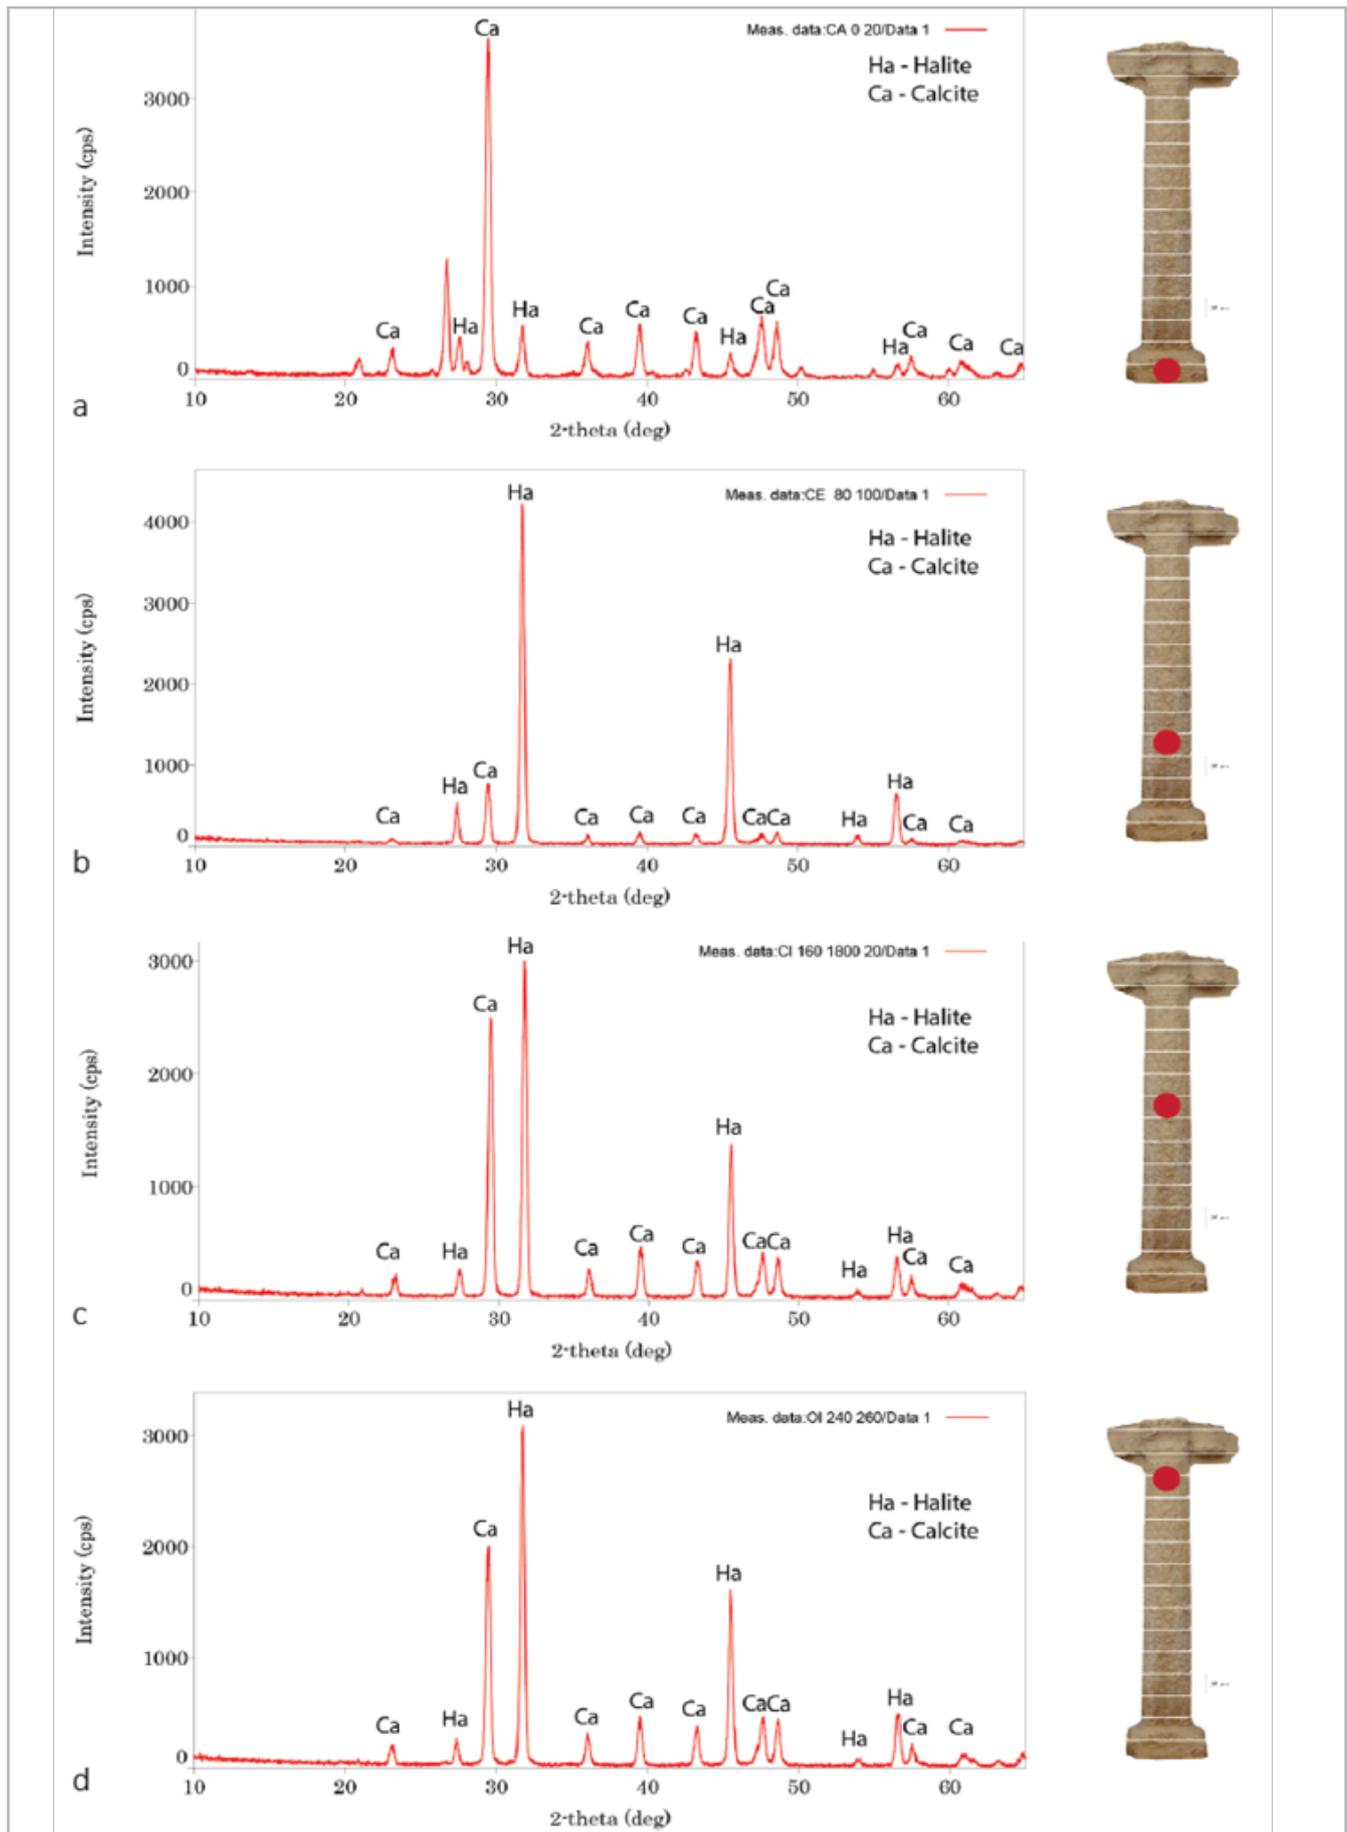
The diffractograms obtained and presented in Figure 6, were all very similar. The spectra showed the presence of calcite and halite at all heights. The calcite is attributable to the type of limestone composition, while the halite, a sodium chloride mineral, may be related to the casual presence of chloride salts. [Figure 6]

Figure 6.- XRD Spectrums of saline efflorescence from the base (a) to the top of the column (d).

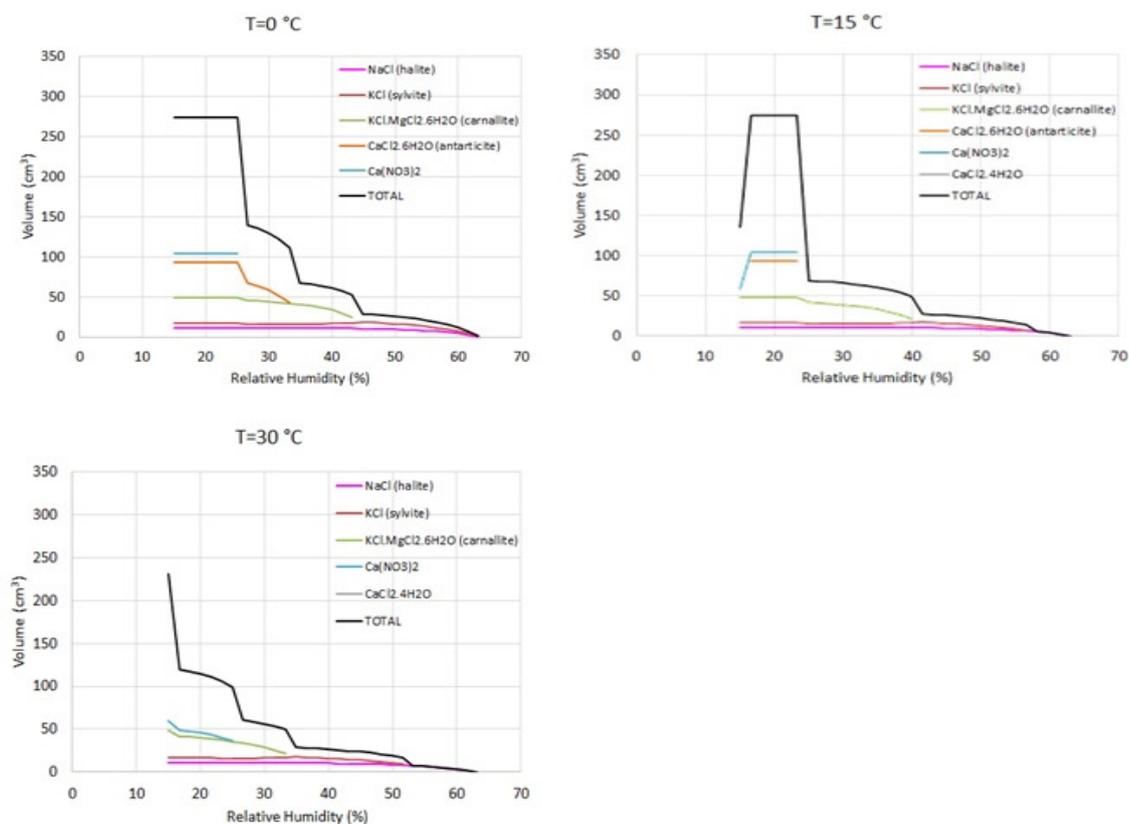
The simulations were done for different values of environmental temperature ranging from 0 to 40 °C with a 5 °C step. Figure 7 shows, as examples, the evolution of the salt composition volume obtained with ECOS-RUNSALT for three of the studied temperatures (0, 15 and 30 °C), being the black line the sum of the volumes of all the salts present according to the program calculations. The charts give us information

Analysing the information enclosed in the chart for 0 °C, we can see that when relative humidity rises, occurs dissolution of the salts. In detail, at about 25% of relative humidity, the calcium nitrate dissolves totally and antarcticite starts a process of dissolution that ends at about 33% of relative humidity. Carnallite starts dissolving also at 25% of relative humidity but the process is slower and only ends with the total vanishing of its crystalline form at about 43%. The other two salts present are sylvite and halite and remain in its crystalline state until 63% of relative humidity. Looking at the chart in reverse direction, for 0 °C, the constant decline in relative humidity produces an increase in the volume of crystallized salts from 63% until 25% of relative humidity. Only when the relative humidity declines, the conditions for the expansion of salts (increase in salt volume) arise and thus for the occurrence of limestone weathering of this base material of the column.

The salt behaviour also depends on the temperature, and thus other temperatures were studied and as the example of Figure 7 shows, the crystallization/dissolution processes have different curve profiles as the relative humidity changes. It also shows that the relative humidity conditions that promote salt crystallization indicate that, according to the “Study room” climatic study, the main salt to crystallize is halite, in accordance with the results of the XRD Spectrums. [Figure 7]

Figure 7.- ECOS-RUNSALT simulations for constant temperatures of 0, 15 and 30 °C and variable relative humidity. The salts in the crystal form are presented in different colours according to the chart legend. The black line represents the sum of the volumes of the different crystallized salts present.

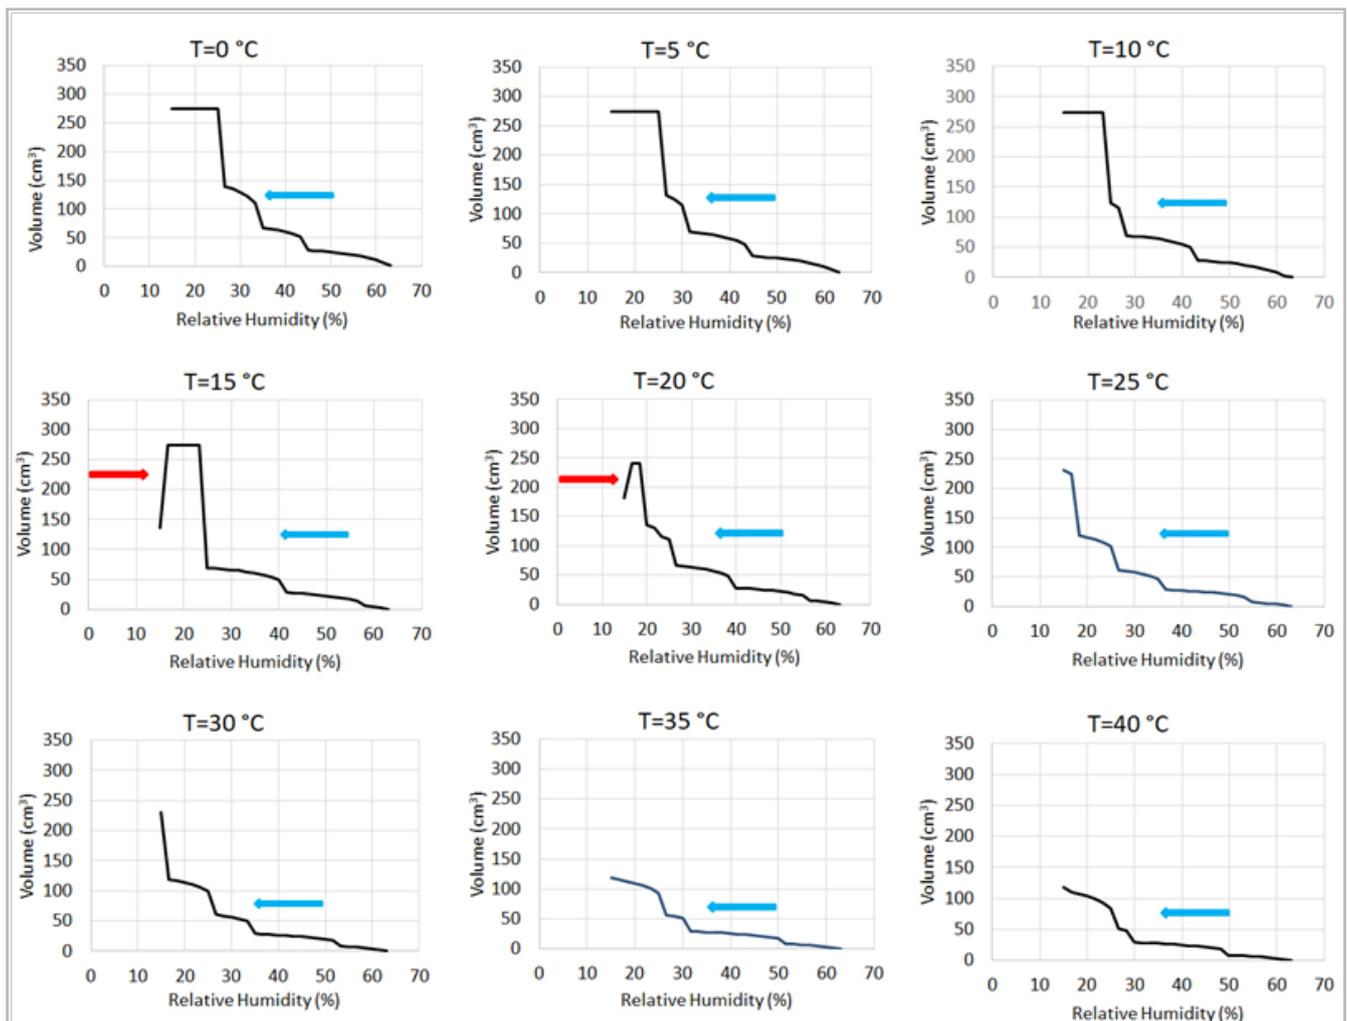
To understand if there were environmental conditions in the "Study room" that might have triggered events of weathering of the column material, the results for all the simulations were analysed in terms of rise and decline of the relative humidity for each computed temperature. Figure 8 shows all the plots of total salt volume against relative humidity for the various temperatures ranging from 0 °C to 40 °C. [Figure 8]

When the simulations are analysed from the perspective of rising relative humidity, there is only two observed episodes of increasing total salt volume at 15 °C and at 20 °C. For example, at 15 °C, the total salt volume increases when the relative humidity rises from 15% to 16,66% (red arrow). In the case of the decline of the relative humidity perspective (blue arrow), in every chart, we can see that there is always a rise of the total salt volume starting at 63,14% of relative humidity until different values of relative humidity, depending on the studied temperature. For example, at 0 °C, the total salt volume increases until 24,96% of relative humidity. This rise, from the perspective of the decline of the relative humidity, has several steps but never decreases, it otherwise couldn't be approached as a single rise episode, but that there are

declining relative humidity zones where the rise of the total salt volume is negligible. For example, in the 15 °C chart, there is a level of almost non varying salt volume when the relative humidity declines from 56% to 43%, while for the same temperature there is a huge increase in salt volume when the relative humidity declines from 25% to 23%. This means that some values of relative humidity are more prone to develop increase in total salt volume than others. This characteristic behaviour is of great interest in the scope of the control of the weathering. If the environmental conditions are controlled within certain boundaries that restrain the increase of the salt volume, the occurrence of weathering phenomena can also be controlled.

Figure 8.- Total salt volume and relative humidity at the studied temperatures. The red arrow indicates the conditions of total salt volume increase when the relative humidity rises and the blue arrow indicates the conditions of total salt volume increase when the relative humidity declines.

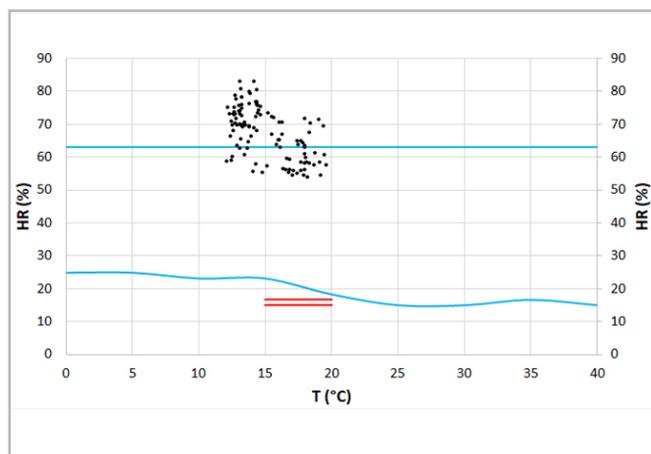
The data collected spawns for a total of 230 days of which the relative humidity declined in 113 and rose in 117 days. Since the conditions for weathering when the relative humidity rises are a very narrow band of relative humidity between 15% and 16,6% and only when those values of rising relative humidity occur between the temperature of 15 °C and 20 °C (see red lines in Figure 9). These values will hardly occur in the Portuguese climate and thus, we opted for not including the data points referring to the relative humidity rise because environmental conditions measured were too far from those values and the chart becomes cleaner and more discernible only with the data points related to the relative humidity decline. [Figure 9]

Figure 9.- Results obtained for the model of the weathered column on the "Study room". For each temperature, the blue lines represent the starting and ending values of relative humidity decline that induce salt volume increase. Between the red lines the same conditions for relative humidity rise. The black dots represent the days when relative humidity decline was detected in the Environment of the "Study room".

The black dots data points for the average temperature and average relative humidity corresponding to the days where a decline in relative humidity was detected, denounced that, among the 113 days in those conditions, 39 fell into a region of total salt volume increase shown between the highest and the lowest relative humidity lines (in blue). This means that in about 17% of all the monitored days, potential weathering could have taken place. In addition, the missing 135 days that roughly correspond to the summer and early autumn (mid-June to late October), are days with lower average relative humidity by comparison with the monitored days

This study, apart from confirming that the environmental conditions theoretically cause weathering events, can also help a conservator-restorer to decide the best temperature and relative humidity values that should help preventing the limestone base material weathering. If the environmental conditions could be kept within certain boundaries of very scarce increase and decrease of salt volume, the weathering could be controlled. In this case, the temperature could be easily kept between 10 °C and 20 °C since we know that the maximum and minimum temperatures measured were respectively 20.5 °C and 11.9 °C. On the other hand, for these temperatures, Figure 8 shows that the increase in total salt volume starts when the relative humidity falls below 63,14%. By controlling the relative humidity at 65% there will be no increase or decrease in total salt volume, and thus weathering is prevented.

For now, it is known that by controlling the relative humidity at $65\pm 2\%$ in temperatures ranging from 10 °C to 20 °C those most harmful weathering events will be prevented, which is an important fact to take into account when maintaining the site.
