Identification of documented constructive stages of the San Ignacio Bridge (Aguascalientes, Mexico) using electrical resistivity tomography (ERT)

Keywords: Electrical Resistivity Tomography, San Ignacio Bridge, constructive stages, historical information

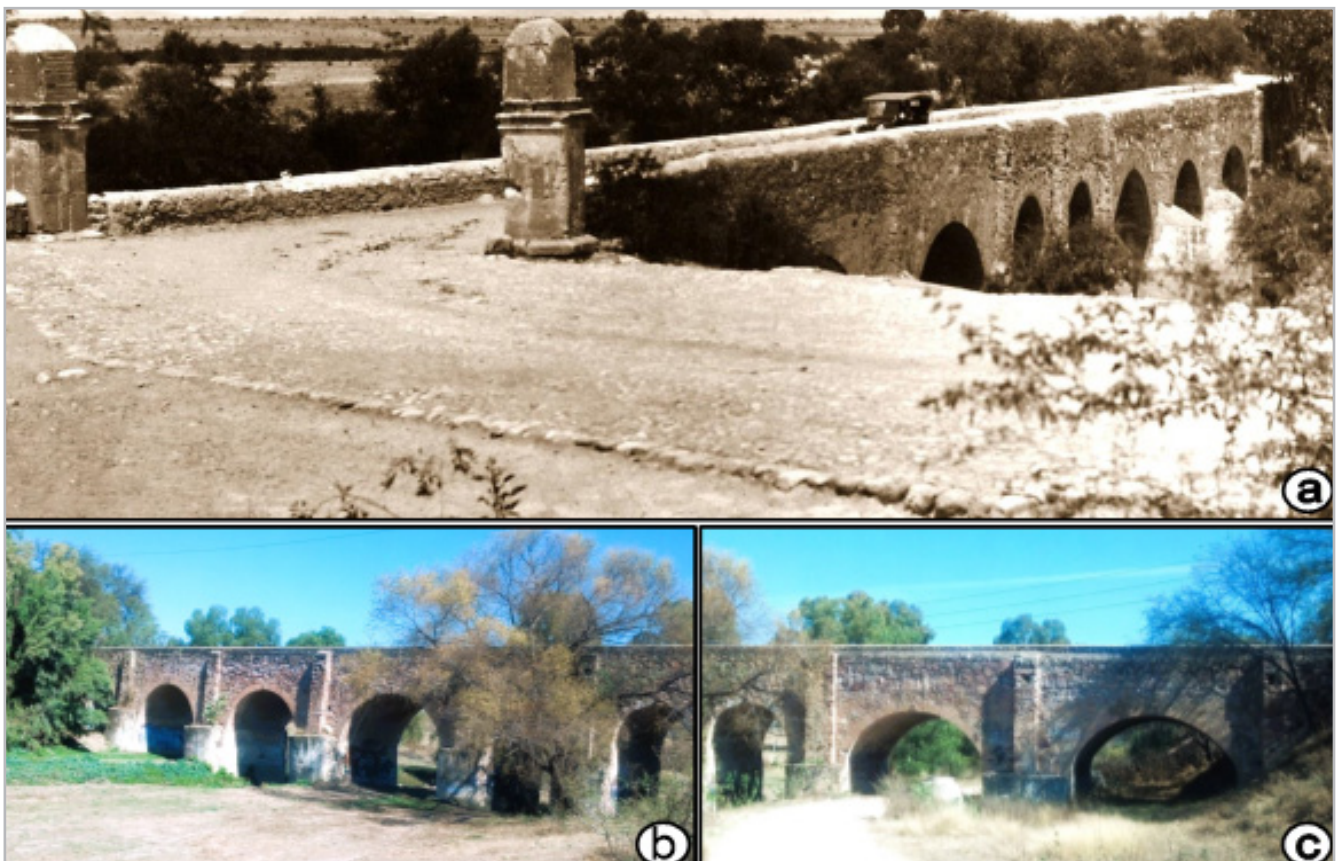
Figure 2.- Old and recent images of the San Ignacio Bridge. a) Photo from the beginning of the XX century. Original boulder paving and the approach with a different direction than the current one. b) Arcs from axis A to H are shown. c) Arcs from axis G to J are shown [Figure 4].

The latter two events are evidenced by a photograph from the early 20th century [Figure 2a], which depicts one edge of the bridge showcasing the original paving and an approach that followed a different direction than the current one. Below is a summary of the events [Table 1] described above:

The last two events mentioned above are corroborated in the photograph at the beginning of the 20th century, depicting one edge of the bridge. In the photograph, the original stonework and an approach that follows a different direction to the current one can be observed [Figure 2a].

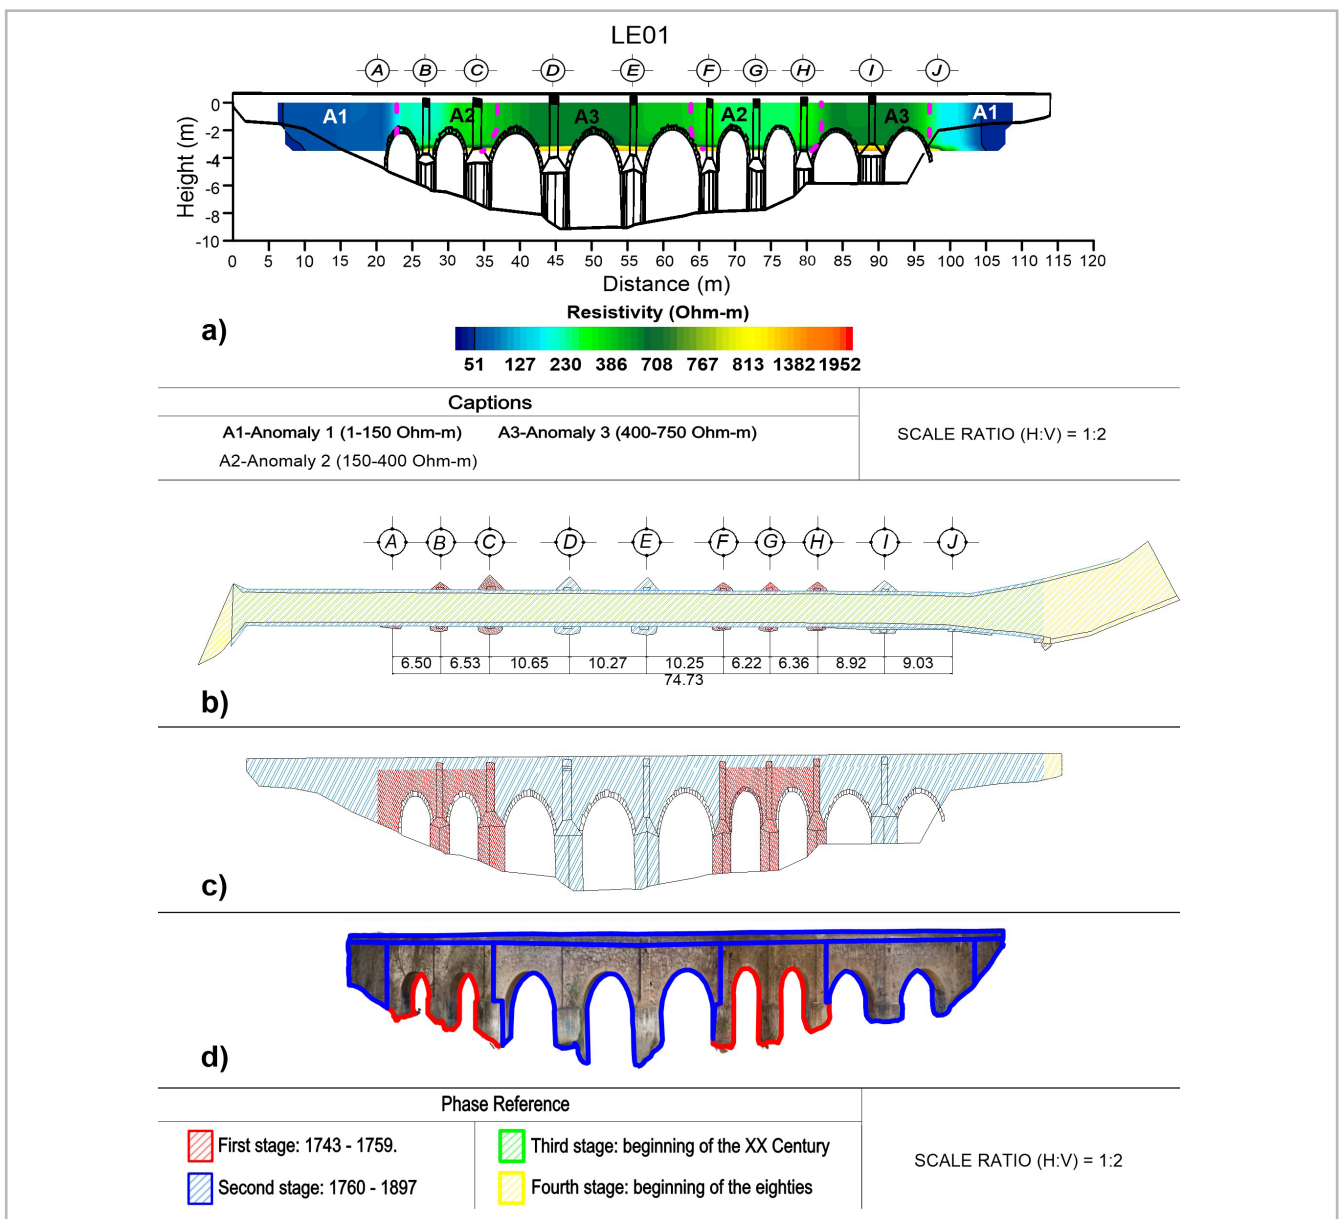
Figure 5.- Identification of the construction stages in the floor plan and elevation, based on the anomalies interpreted from the LE01 model and the historical information. The reference axes of the bridge located in each of the pillars or support structures are shown. a) Profile LE01 superimposed on the longitudinal section of the bridge. Resistive anomalies A1, A2 and A3 are identified. b) Plan view of the bridge with identification of the construction stages mentioned in historical records. c) Longitudinal section of the bridge with the construction stages defined from the resistive anomalies in figure 4a. d) Image of the southwest side of the bridge obtained from a photogrammetric model. Two of the construction stages are identified.

The field data were processed using the RES2DINV software to develop the resistivity model shown in Figure 5a, which shows the resistive anomalies due to the construction elements and their materials, and a distortion of the anomalies due to the effect of the geometry.

At both ends of profile LE01 [Figure 5a], between 7 and 23 m and 98 to 108 m, resistivity values were below 150 Ohm-m are represented in blue and cyan colors. Two light green zones are defined in the portions between 23 and 36 m and 64 to 83 m, with resistivity values in the range of 150 to 400 Ohm-m. Between 36 to 64 and 83 to 98 m, two dark green zones are defined with resistivity values in the range of 400 to 750 Ohm-m. The model reveals significant variations in resistivity between the different zones, establishing clear boundaries.

Between axes C- F and H-J in figure 5a, the A3 resistive anomaly is identified with values between 400 and 750 Ohm-m in dark green color, which may correspond to the partial collapse of 1759 occurred mainly in this area and described in the narration of Boils-Morales (2009). These findings are supported by the field investigation conducted on the bridge, during which a change in the geometry of the arches and a slight rotation of the pillars located on the E and D axes were observed. Furthermore, physical modifications in the materials, such as changes in color and texture, were observed in areas without coating on the intrados of the arches.

On the other hand, the low resistivity anomalies A1 located at both edges of the bridge [Figure 5a] are spatially related to the construction stage 4 [Table 1] which corresponds to the modification of the approach slabs to align with the new layout of the "Antiguo Camino a San Ignacio" in the early 1980's. The fill material used in the construction of the approaches has a higher moisture content [Figure 5a], since it lacks lateral confinement that blocks the flow coming from the avenues that connect with the bridge and from its sides. Furthermore, it only has a wearing course, without the presence of the second layer of tiling with blocks of foundry slag found on the Bridge roadway, which could reduce water infiltration.
