## Material characterization and restoration of mural paintings of El-Muzzawaka Tombs, Dakhla Oases, Egypt

Mona F. Ali, Hanaa Shawki, Hussein Marey Mahmoud

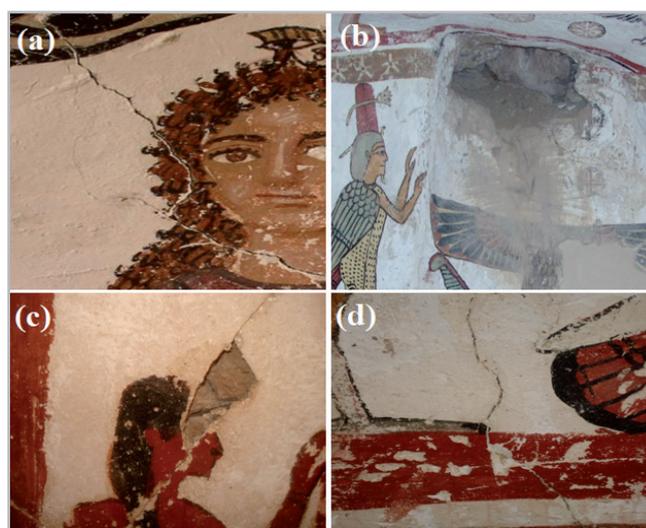
**Figure 3.-** Examples of deterioration forms on the wall decorations of El-Muzzawaka tombs (e.g. plaster loss and several cracks) (a), (b) the tomb of Petosiris, (c), (d): the tomb of Petubastis.

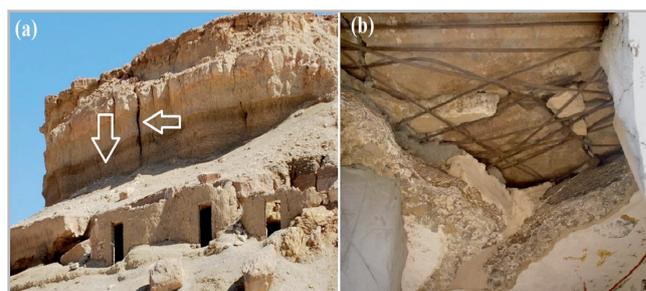
Further, the rock structure displays several faults, major cracks and heavy rock slabs which cause catastrophic rock collapse and loading of overburden on the pillars and ceilings of the tombs. In old restorations of the tombs, metal framing elements were added to reinforce the ceilings of the tombs. Unfortunately, these iron bars caused additional pressure and induced weakening to the ceilings and the painted plasters [Figure 4].

**Figure 4.-** (a) geotechnical defects in the rock structure of the areas, (b) failure of the ceiling of the tombs and the iron bars used in old restorations of the tombs.

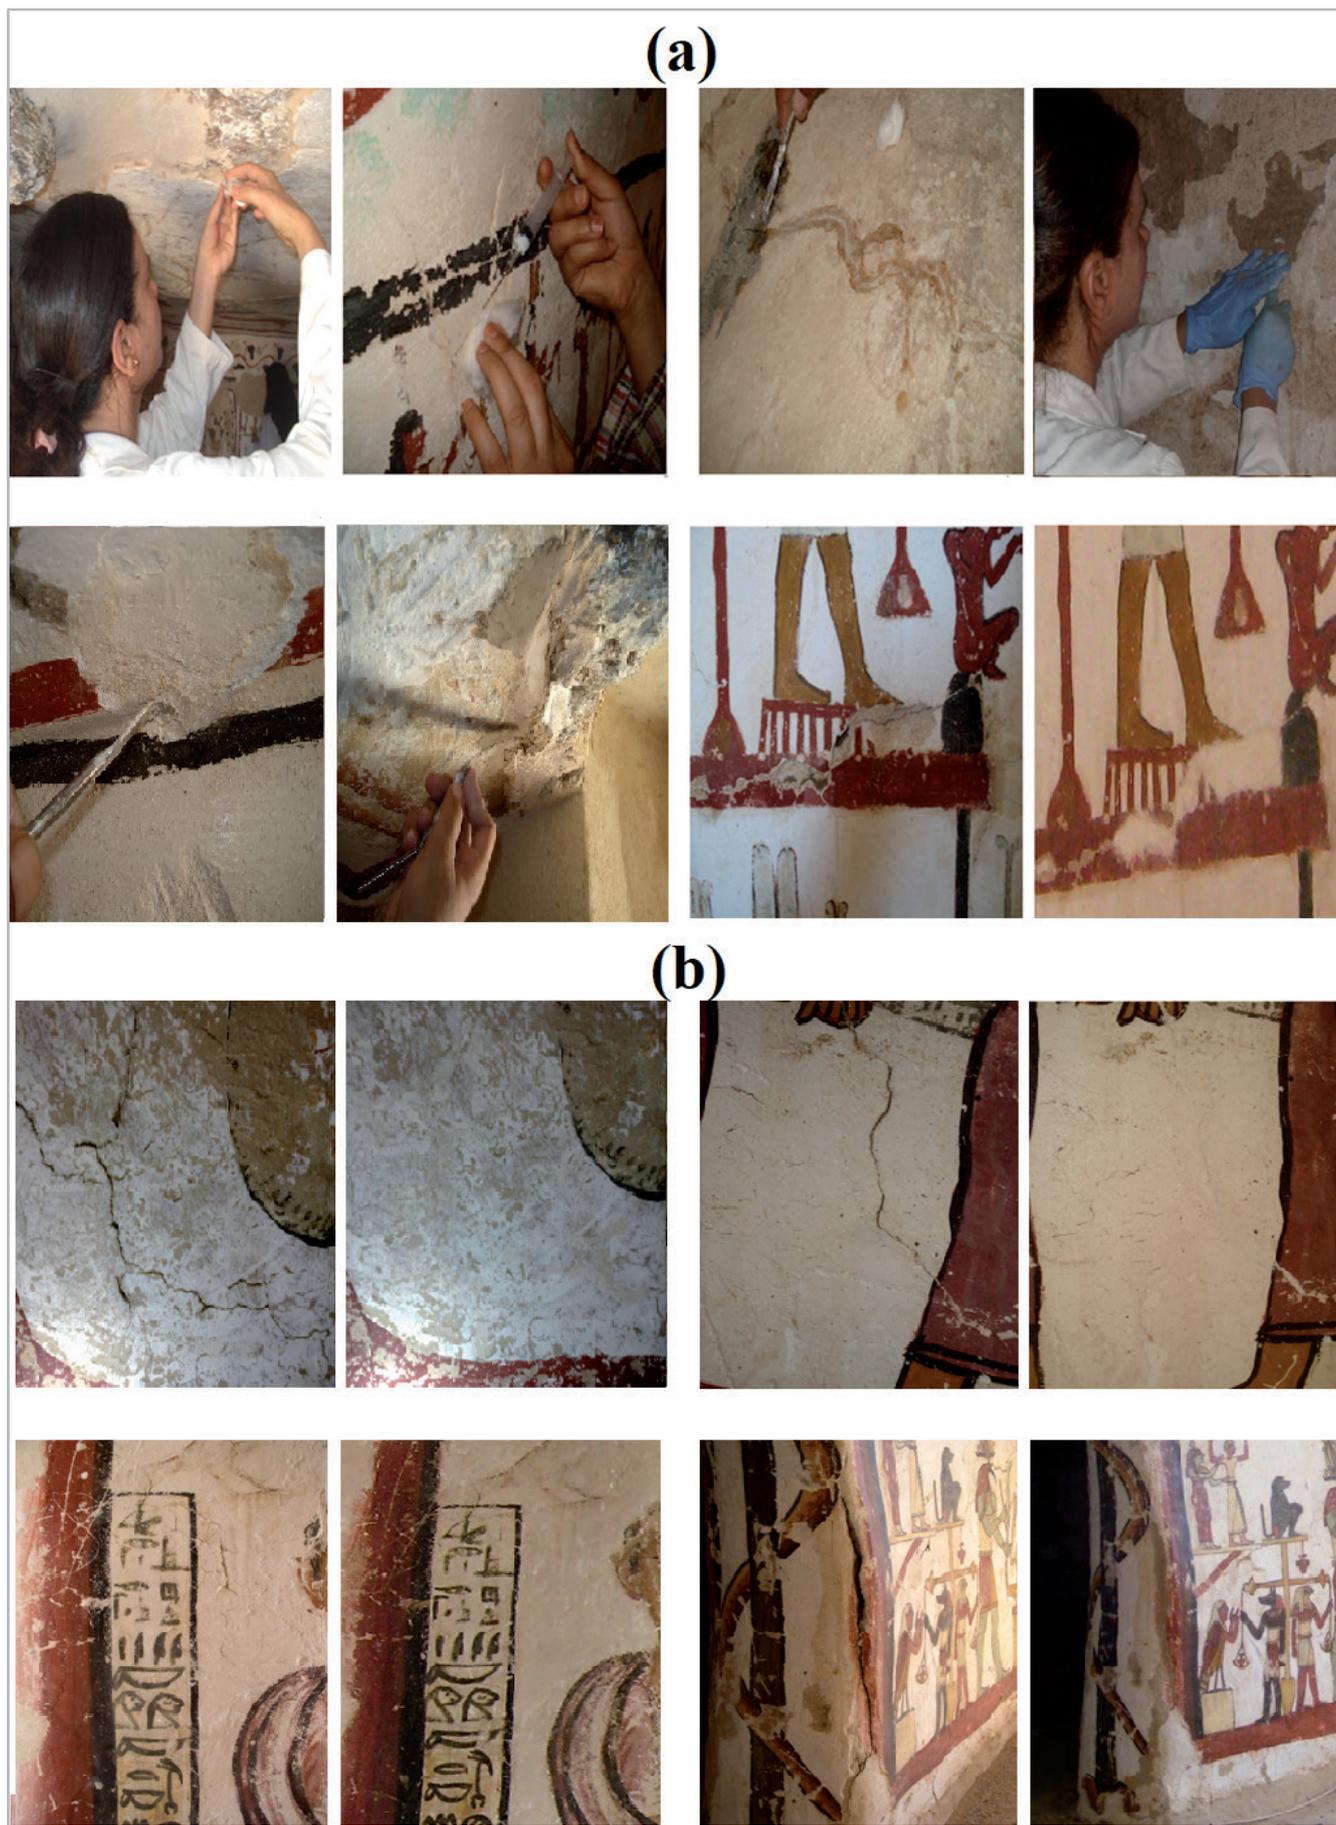
**Figure 16.-** Shows representative restoration procedures applied for the murals in the tomb of Petubastis (a) and the tomb of Petosiris (b).

As a result, several restoration procedures were necessary to stabilize the condition of the damaged murals in the tombs. The restoration steps varied according to the state of preservation for each wall. Such operations included cleaning, reattaching of flaking paints, application of injection grouts to detached layers, reconstruction of missing parts in the plaster, repair of wide-open cracks, and consolidation of the painted surfaces. Figure 16 displays some procedures applied to restore the murals of the studied tombs.

the detaching of tiny flakes from the underlying ground. First, clearing away the dust from the outer surface was done by soft brushes followed by wetting the detached flake by an ethyl alcohol. To reattach these flakes, a drop of an acrylic-based emulsion of Primal AC 33 was mounted at the underside in the separated point. Flattening the flake was made by a ball of absorbent cotton. Then, a gentle pressing using a silicon paper sheet and spatula was performed to re-adhere the detached flake to the wall.

a) cotton q-tips were soaked into the cleaning solution for a minute, then they were used for wetting the polymer layers to be easily removed; b) in some areas, tissue papers were immersed in the cleaning solution and applied directly onto the surface. The tissue poultices helped to soften the polymer layers, which then were removed easily using a scalpel.

For plasters that suffer from detaching and crumbling, injection grouts are usually applied (Baglioni et al. 1997). A series of experimental procedures were performed on different suggested formulas. Comprehensive laboratory tests were undertaken to define the physical and mechanical properties of the restoration mortars and injection grouts. Based on the chemical-mineralogical characterization of the paint layers, a number of restoration mortars and grouts was prepared. The grouts were tested according to related international standards (Kemp 2009). The experiments showed that the best formula is the one consists of: 1 part slaked lime, 2 parts powdered sand (300 µm), 1 part microballoon, 1 part bentonite and 1 part Addicrete BVD. This formula showed satisfactory results in terms of the physical and mechanical properties. Before injecting the grout, a dry cleaning by an air blower was applied. The injection formula was applied using plastic syringes (with size of 5 cm to 60 cm). To ensure a good penetration of the grout, the edges of the plaster layers were closed prior to the injection process.

For the narrow cracks, an initial cleaning with a solution of water and ethyl alcohol was applied. Then, a diluted emulsion of Primal AC 33 (1:4 in water) was injected into the cracks using a syringe. But for the wide-open cracks, a restoration mortar was essential. The cracks were cleaned mechanically, by soft brushes and air blowers, to remove the damaged remains. Then, a restoration mortar consists of slaked lime, sand, clay, and Primal AC33 was applied using a metallic spatula.

The missing parts in the plaster layers were re-filled using a restoration mortar. The deteriorated remains were removed and then the voids were wetted before applying the mortar. A compatible mortar similar to the original plaster layer was used. Before applying the mortar, the stability of the plaster edges was tested and the friable areas were subjected to a topical consolidation treatment. Then, the mortar was applied in form of multi-layers with the aid of mechanical compressing using a metallic spatula to ensure a good cohesion with the underlying substrate.
