## 5<sup>TH</sup> EDITION OF THE INTERNATIONAL MEETING ON RETOUCHING OF CULTURAL HERITAGE

18<sup>TH</sup> - 19<sup>TH</sup> OCTOBER  
2019

# Filling and retouching techniques in outdoor tiles with saline efflorescence problems. A case study

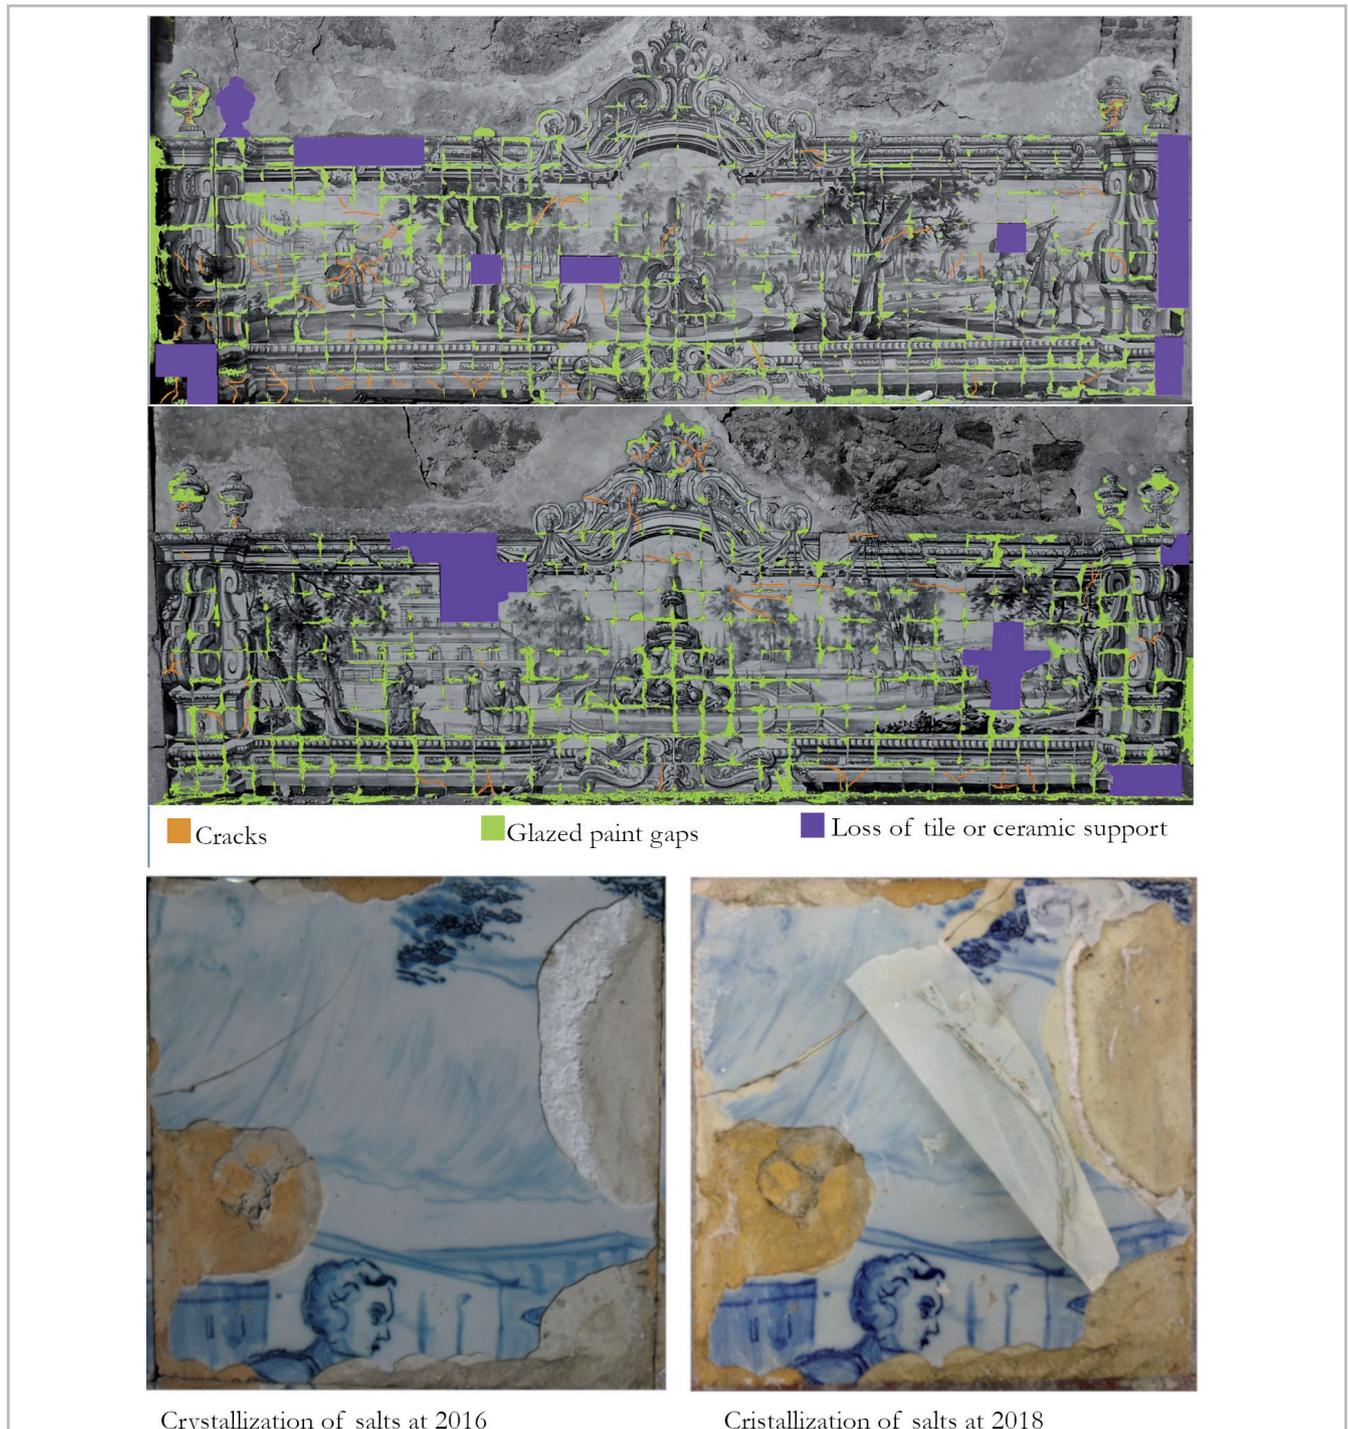
The condition of the panel was alarming due to the quantity of gaps in the glazed surface and the number of missing elements, but also due to fractures in its elements and blisters between the tiles and the support [Figure 1]. This state of conservation was due to the state

**Figure 1.-** Mapping of the pathologies and images of tiles with salt crystallization.

of degradation of the support wall, which was cracked causing shifts that broke the tiles and also by water infiltrations of both ascending and descending origin. The wall had degraded plaster which amplified the degradative action of the water causing the rotting of mortar support but also contamination with salts in the whole system, becoming harmful, since the panels are severely exposed to wetting cycles and drying due to their facing south.

It was possible to determine that the majority of the glaze losses were mainly caused by saline efflorescence which was determined by observing the morphology of the gaps, located at the ends of the tile, in a process of detachment from the outside to the interior in the shape of a half moon, but also due to the crystallization of salts that was visible to the naked eye. It was also possible to analyze, that in a space of two years the crystallization of salts, at the glaze interface with the ceramic support was able to detach about 2mm of the glazed surface [Figure 1]. This problem would continue to exist because of the support's nature and its exterior condition, something that the panels would still be bound to. Being so, it was necessary to find a conservative solution to counter the saline efflorescence problem, making the fillings with a lime mortar - marble powder, fine siliceous sand/grit and lime putty, with the proportions of 1:3 - to make them porous and pervious, so that through their capillary strength they could contain the salt crystallization within themselves, impeding the efflorescence's from crystallizing between the glaze and the ceramic body, preventing the glaze's degradation.

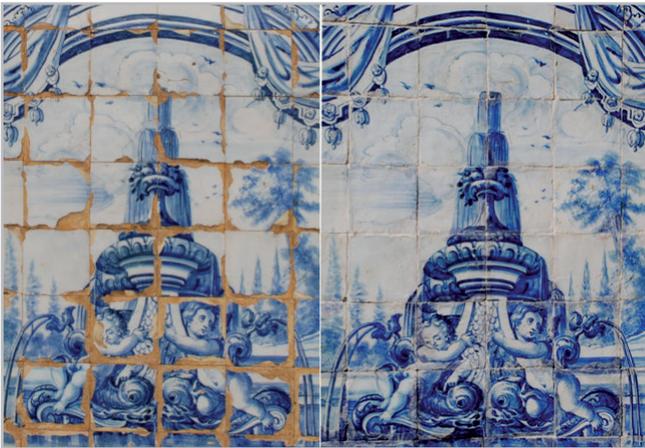
However, this kind of retouching implies major finishing problematics such as the contrast of a glossy glazed coating, opposed to a textured matte surface, which immediately reveals the different materials used. It is also difficult to paint precise details at this scale despite of the good continuity of shapes and tones, these factors compromise the level of retouching mimesis. The imposition of this filling and retouching techniques implies that on close observation the differences amongst the fillers and the original are clear, revealing the damage that the tiles suffered and how much the state of degradation advanced. Even though these differences between materials are a consequence of the measures taken for the conservation of the glaze and not an intended effect of the intervention, these came in accordance with the aesthetic criteria of the rehabilitation intervention that accepted the ruinous features of this part of the building. In this way the differences of texture had to be embraced for the sake of the chromatic layer, accepting the ruinous state of the panel. [Figure 2].

**Figure 2.-** Photograph of a detail of the panel before and after treatment with lime mortars and retouching with al fresco technique.

Since the permeability of the filling's material is imperative for the glaze's conservation, the chromatic retouching had to be adapted to these features. An *al fresco* technique was selected.

This technique consists in applying this painting *la fresco* techniques to retouching. Lime-resistant pigments diluted in lime water, in the mortars still fresh, so that it is incorporated in the mortar matrix. (Mayer 1993) In this way the pigment is fixed with the carbonation process, allowing the pigment to be kept in open air conditions, without needing a protective layer that would harm the mortar's permeability.

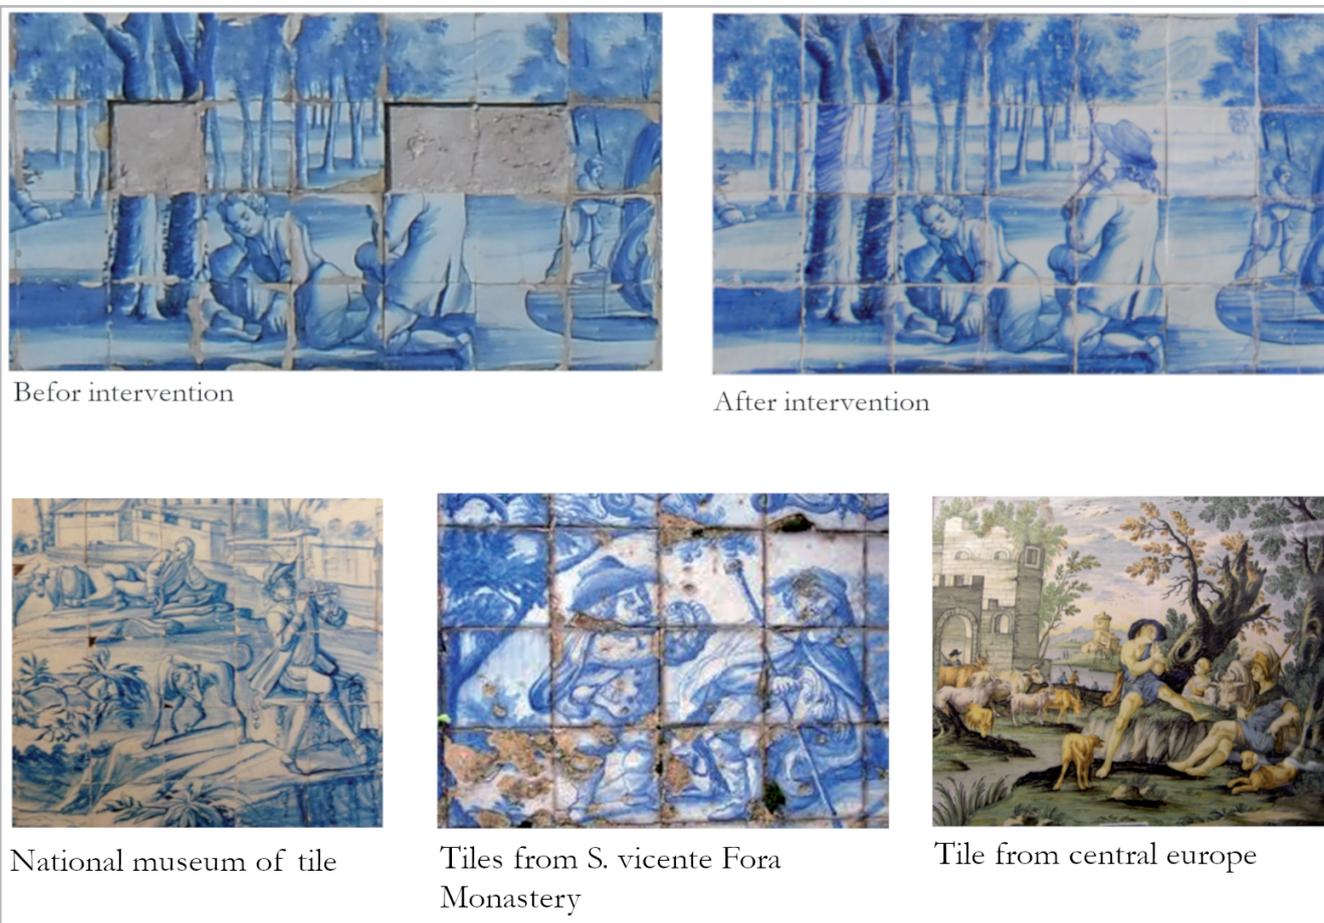
The first scene shows one figure, with closed eyes on a relaxing state and next to her, an incomplete person was standing on his knee, but the corresponding tile of the head was not found. After analyzing and making a comparative study, it is suggested that it is a musical theme. This conclusion was drawn from the collected data of other panels with musical scenes, which frequently represent two shepherds playing the flute, coinciding with the context and garbing of these figures. (Rocha 2012) It was then possible to determine that the first figure is hearing something pleasant based on the face's expression, and the second incomplete figure is positioned as if it were playing music. Based on this information, the second figure was reconstructed with a face of a person playing the flute [Figure 3].

**Figure 3.-** Original state of the panel (a); final result (b); other images from the same period: c) detail of a panel from the National Tile Museum; d) tiles from Vicente de Fora Monastery and e) tiles from central Europe

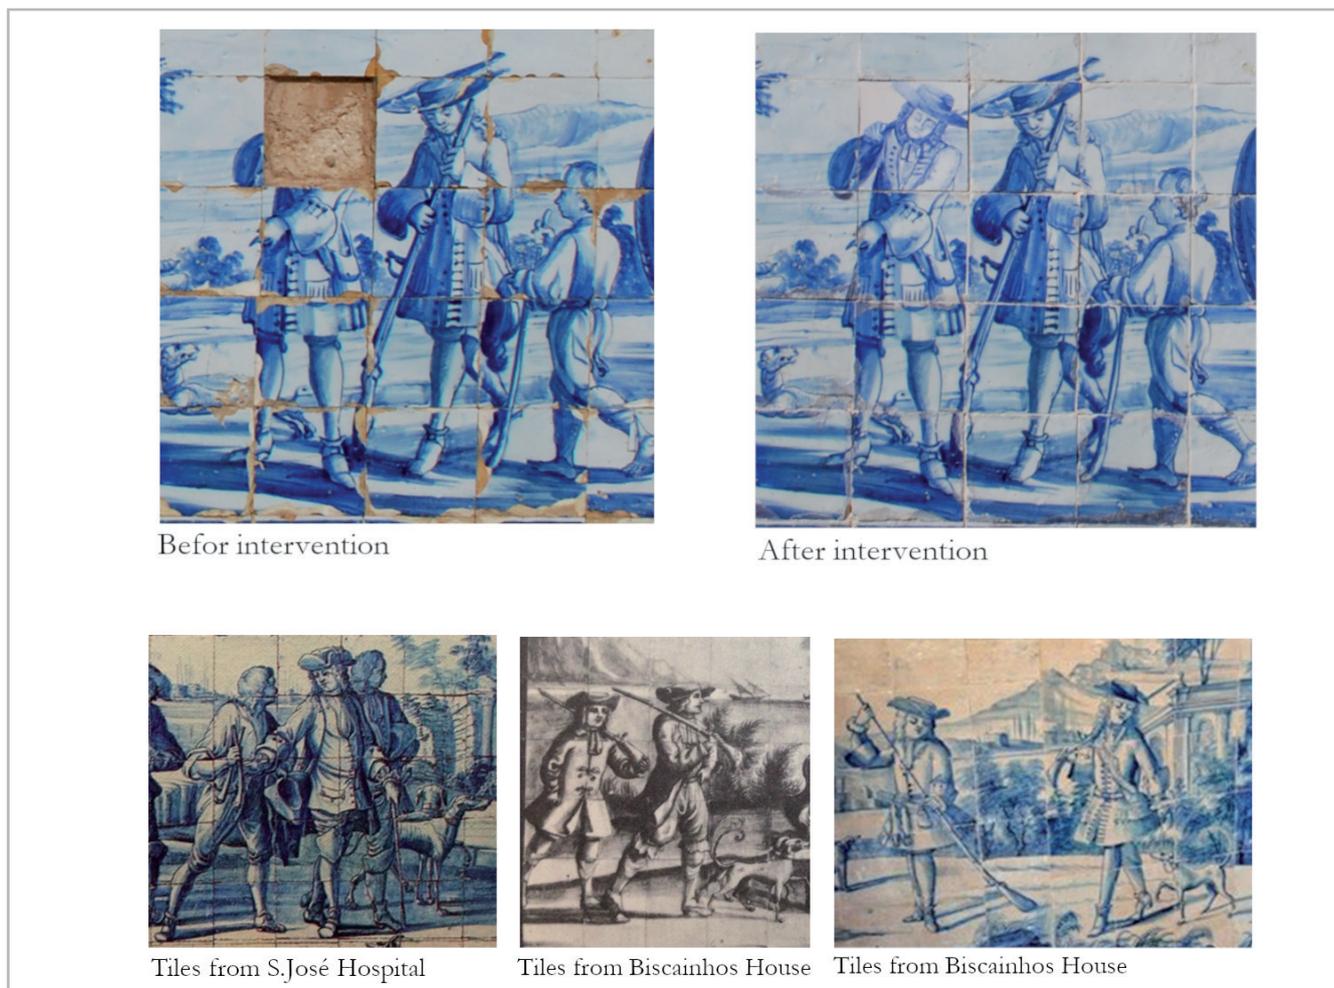
This scene is about two hunters with a dog, but it was missing the face of one of the hunters. A very similar

picture of the same theme, was found on another panel. Based on this representation and on the remaining traces, namely the existence of the finger of the hunter pointing to the dog, a tile was created with the head of the hunter facing down to the dog [Figure 4].

**Figure 4.-** The original state of the panel, the final result and samples of the graphical study applied in this case.

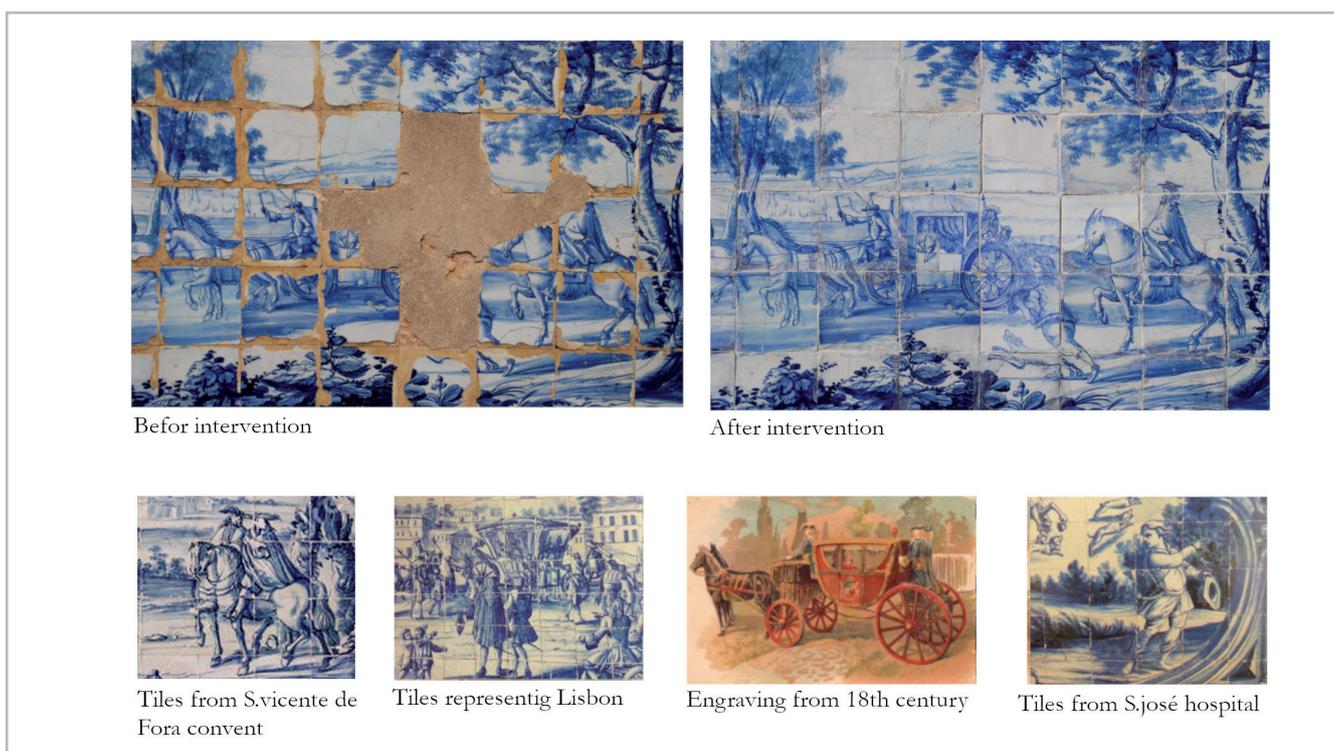
This one is a bit more complex, presenting the arrival of a coach, inside which was possible to identify a lady on a tile fragment. In the surrounding space, it was possible to identify a person running with a dog towards the coach's and a knight on a horse. An investigation of that period's coaches was conducted, as well as representations of coaches in artistic tiles, from which it was possible to reconstruct the shape of the coach and the lady inside it. Still through the observation of other panels, it was possible to understand the representation of the figure with the dog running towards the coach. The shapes were created based on the continuation of pre-existing ones and on data collected through the investigation, reestablishing the readability of the scene [Figure 5].

**Figure 5.-** The original state of the panel, the final result and samples of the graphical study applied in this case.

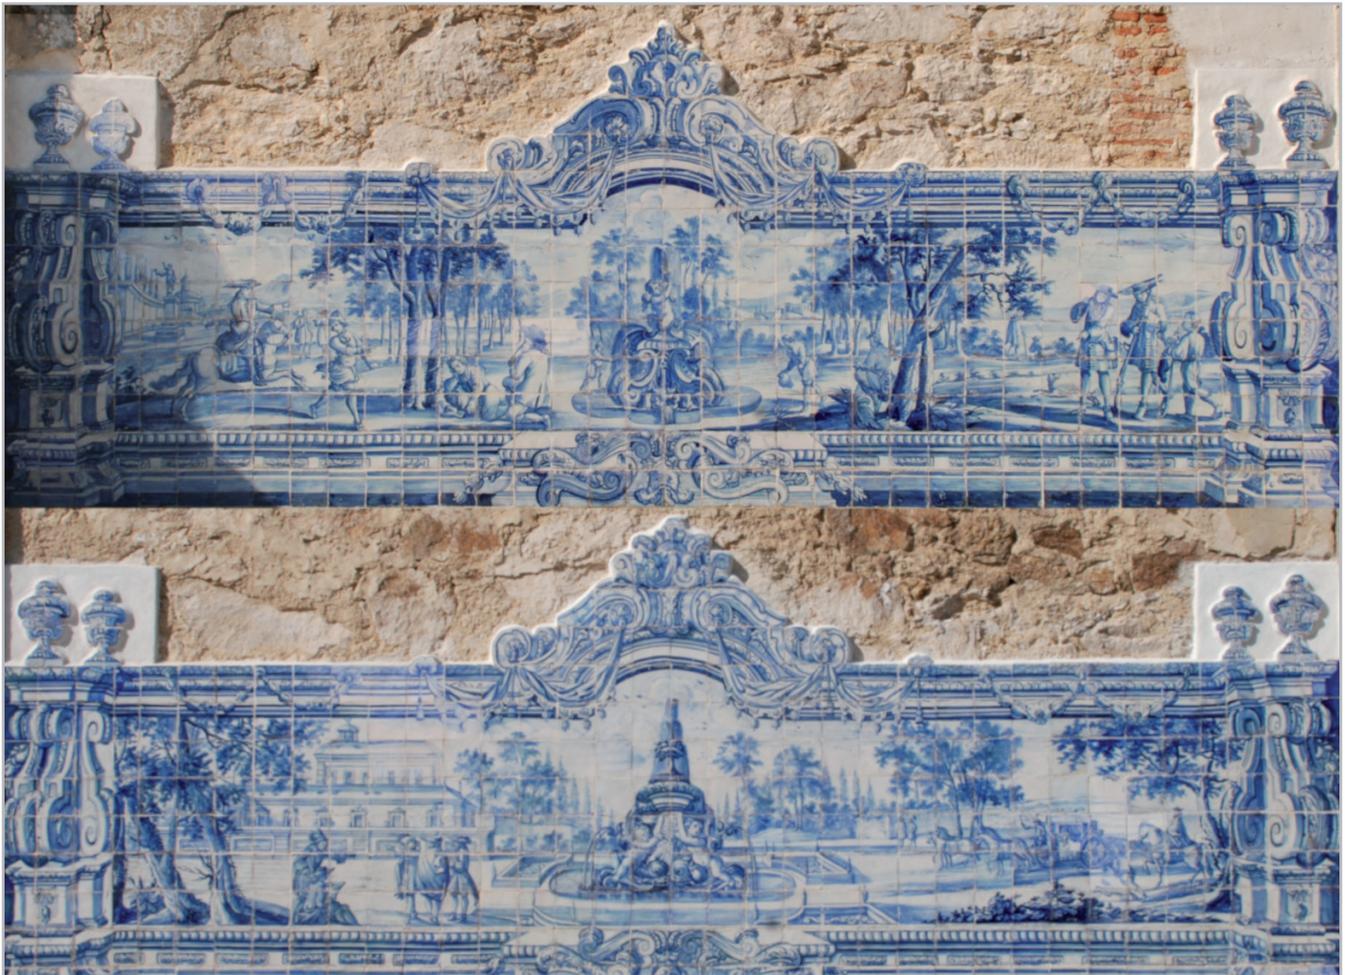
The reconstruction of the incomplete scenes results perfectly well on the return of the legibility, making the reading of the painting fluid again. [Figure 6].

**Figure 6.**-The final result of the intervention.
