Preliminary investigation of the preparation of repair mortars for the Temple of Diana, Mérida, Spain

Duygu Ergenç, Rafael Fort González

Key words: conservation, Roman mortar, microstructural and thermal analyses.

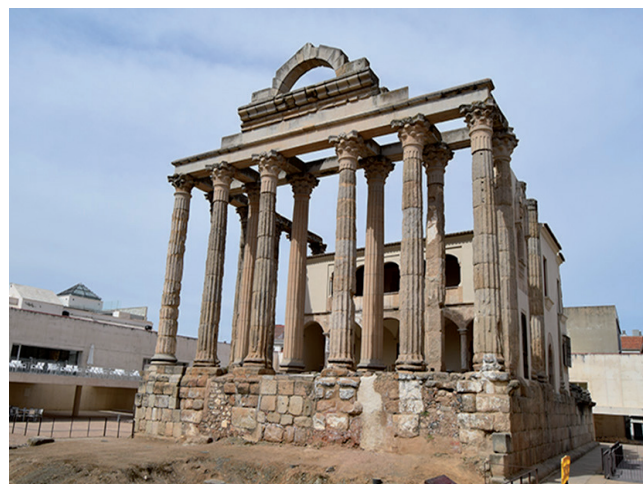
Figure 2.- Image of Temple of Diana.

The M1 sample is light brown-beige colour mortar that constitutes 5 mm to 4 cm diameter coarse aggregates (*caementa*) and lime lumps 1-4 cm in size. Poorly sorted aggregates in the porous lime binder are angular to sub-angular, which indicate crushed fragments of the rocks [figure 2]. Sample M2 is a whitish mortar that has coarse 5 mm to 2 cm diameter aggregates (*caementa*). These poorly sorted aggregates are sub-angular to round in shape. The whitish-yellow M3 mortar sample contains 4 mm to 1 cm diameter coarse aggregates (*caementa*), and 1.5 – 4 cm lime lumps. Poorly sorted aggregates in the porous lime binder have angular to sub-angular forms. Sample M4 is whitish in colour and contains smaller, (0.5 to 5 mm diameter) aggregates. Moderately sorted aggregates in the porous lime binder have angular to sub-angular forms, indicating crushed rocks. Sample M5 is whitish-beige mortar with smaller aggregates (0.5 to 5 mm in diameter) and 2 cm lime lumps. Moderately sorted aggregates in the porous lime binder have angular to rounded forms. Although no ceramic fragments were visible to the naked eye, lime lumps were observed in the samples M1, M3, and M5.
